Sx Tool Download

Index

Smart building system Sx2WEB24

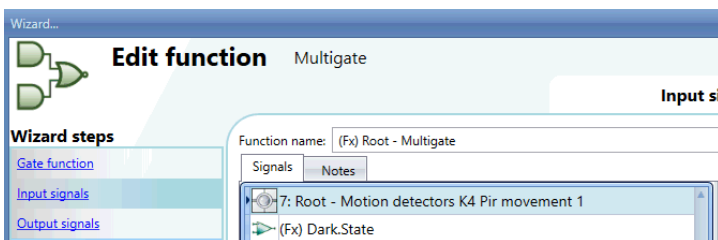
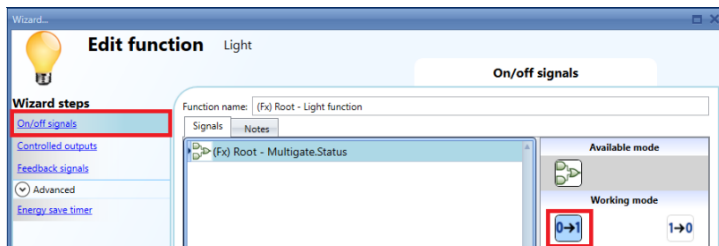
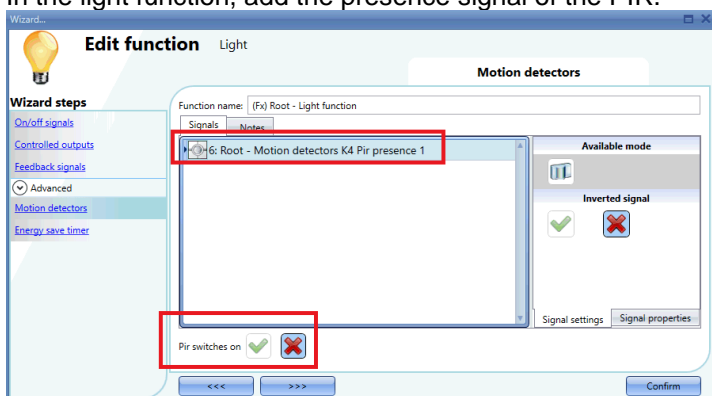
Energy save timer is not reloaded when the light level is above the threshold

The automation of the light function puts together lux meter, PIR and energy save timer. When the lux value is below the threshold and the PIR detects movement, the light goes on. At this point the lux value goes above the threshold and the energy save timer is not reloaded anymore, therefore the light goes off even if there is presence in the room.

Create an external analogue comparator that is used to define the “dark” condition. Use the comparator function as input of a multigate "AND" function combined with the *movement signal* of the PIR sensor.

Use the multigate as input signal (*On/Off Signals* tab) of the Light function.

In the light function, add the presence signal of the PIR.

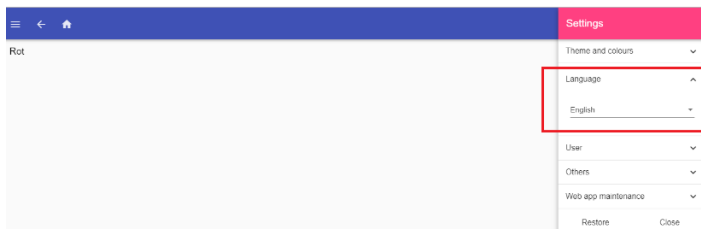
Reports created from web App shows wrong month

In the web app *Reports* window, you have created a template for a report in October 2018 but when you save and create the report, November 2018 data logs are shown.

The problem is due to the wrong default language that is automatically set by the Web App.

To fix this issue, navigate the web App settings, select the English language, then select again the correct language and save to apply the settings.

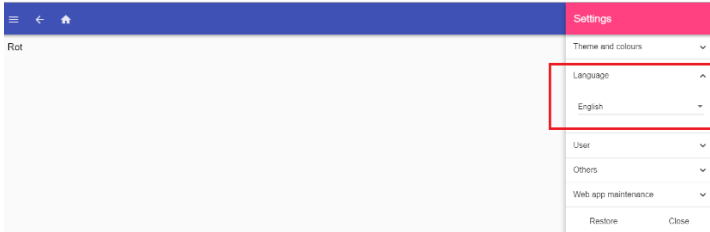
Not possible to edit calendar activity from the web App

When you try to edit a calendar activity from the Web App, you get an error and the login page is shown.

The problem is due to the wrong default language that is automatically set by the Web App.

To fix this issue, navigate the web App settings, select the English language, then select again the correct language and save to apply the settings.

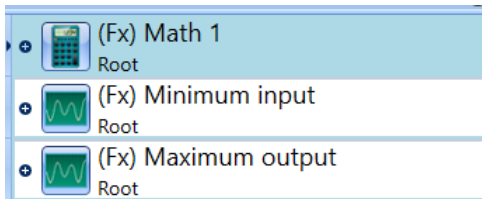
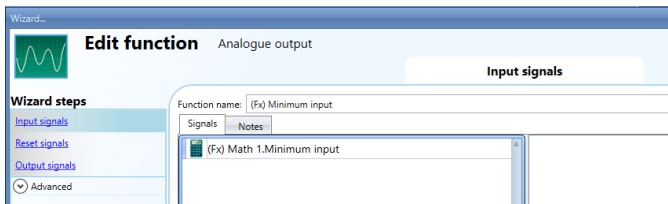
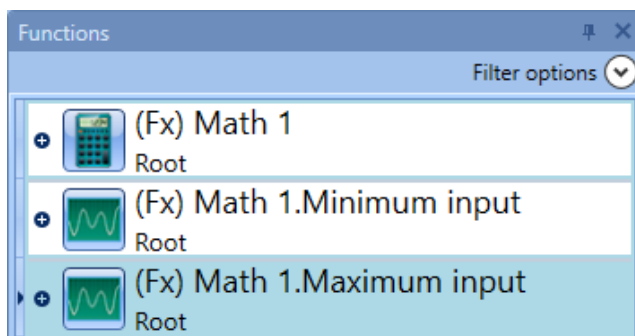
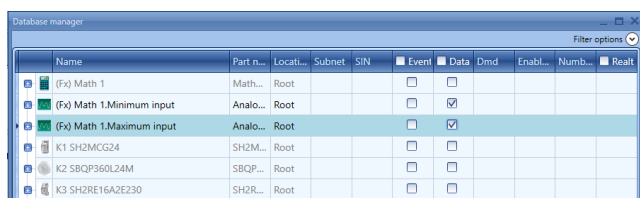
Not possible to log additional function status in the Database

In the Database window, the additional function status of a function is not available and it is not possible to log them into the Database of the system.

- a. Add to the project one Analog Output function for each additional status not available in the Database.

- b. Add to the analogue output function the additional status of the math function.

- c. Change the name of the Analog Output functions in order to have a clear description of the additional status (es. function_name” + “additional_status”).

- d. In the DB Manager add to the Database the Analog Output function.

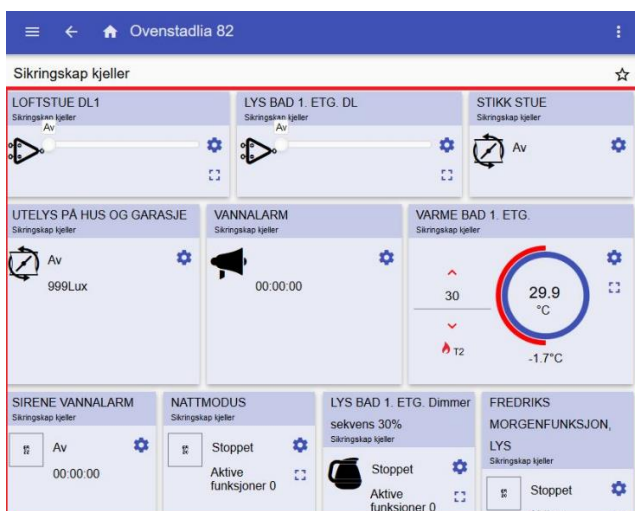
Wrong icons shown in the web App

After a firmware upgrade of the system the icons in the web App are not correct (the icons are messed up or missing).

The error is due to the cache of the web browser, the issue will be resolved cleaning the cache and logging-in again in the web App.

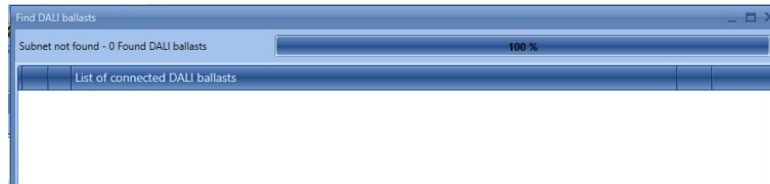
Not possible to scan the DALI network “subnet not found” error message appears

After adding the DALI module to the project, from the DALI module discovery window, the user tries to find the ballast connected, but when the search button is pressed, the discovery ends immediately with an error “Subnet not found”

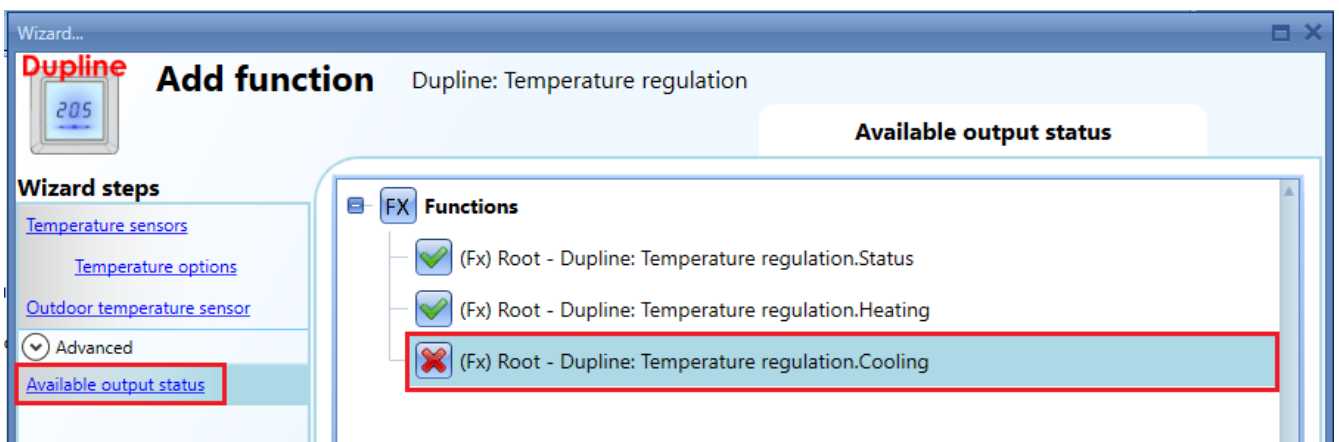
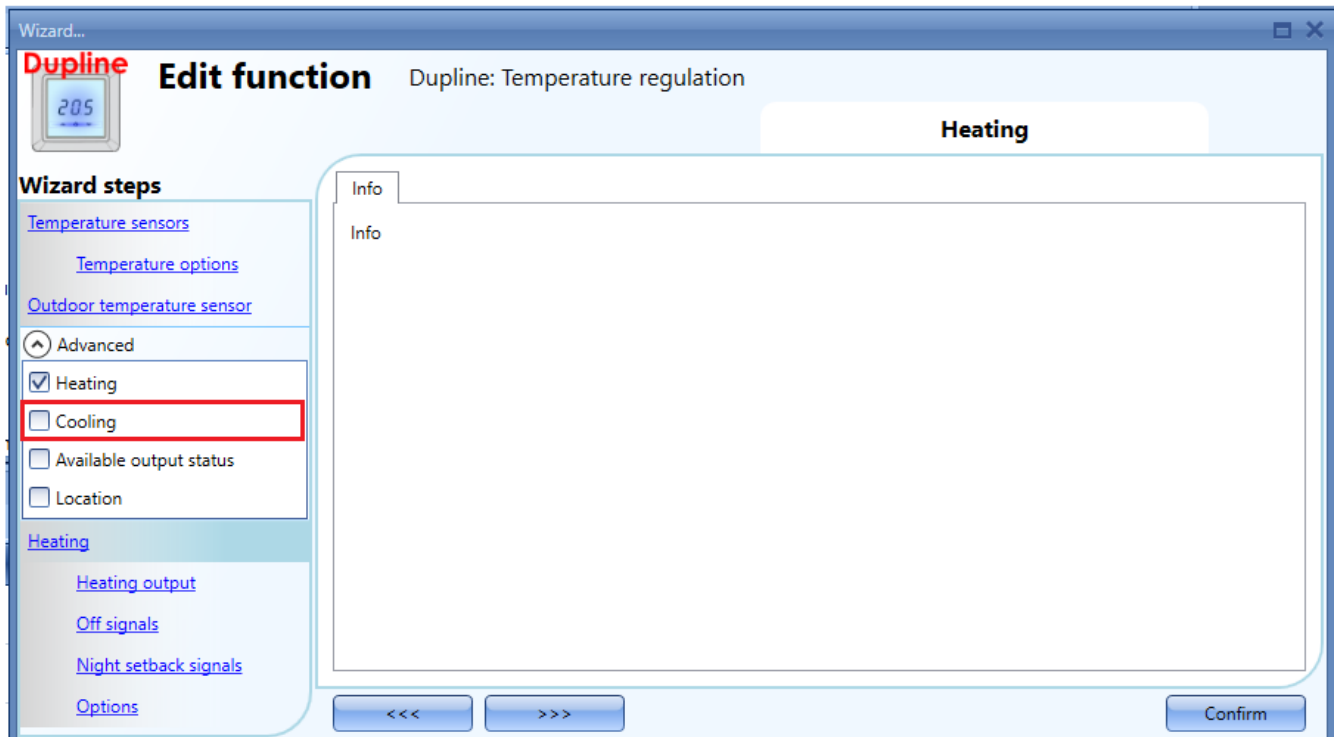
Dupline temperature regulation function deactivates the heating setpoint

When the advanced field Cooling is selected in the Dupline temperature regulation and there is no output signal used, the temperature function activates the cooling set point every time the configuration file is sent to the controller, consequently the heating function goes from heating T1 to TOFF and stops heating. This problem happens also when the controller restarts because the system loads the configuration at start-up and the cooling setpoint is activated.

In the advanced menu "available output status" the signal *temperature regulation.Cooling* should be deactivated.

The advanced menu "Cooling" should be unselected.

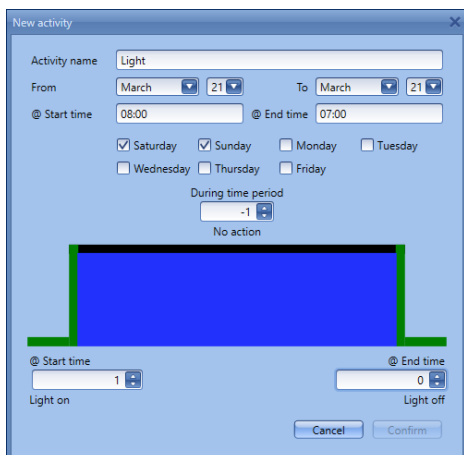
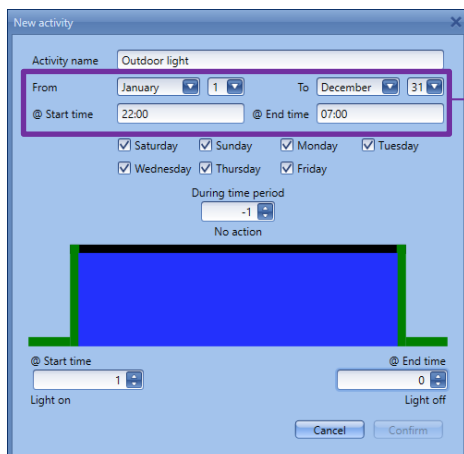
Calendar activities cannot be added

When a calendar activity is going to be added either in the *Local calendar* of the functions where it is available in the *Advanced* options, or in the *Global calendar* function, after filling the required fields the *Confirm* button cannot be pressed (this is shown in grey colour).

The *Activity name* field has to be entered

At least one week day has to be selected

a) With the same selected interval date (*From... To...*), it is necessary to set *@Start time* chronologically prior to *@End time*

b) Even with a different selected interval date (*From... To...*), it is still necessary to set *@Start time* chronologically prior to *@End time*

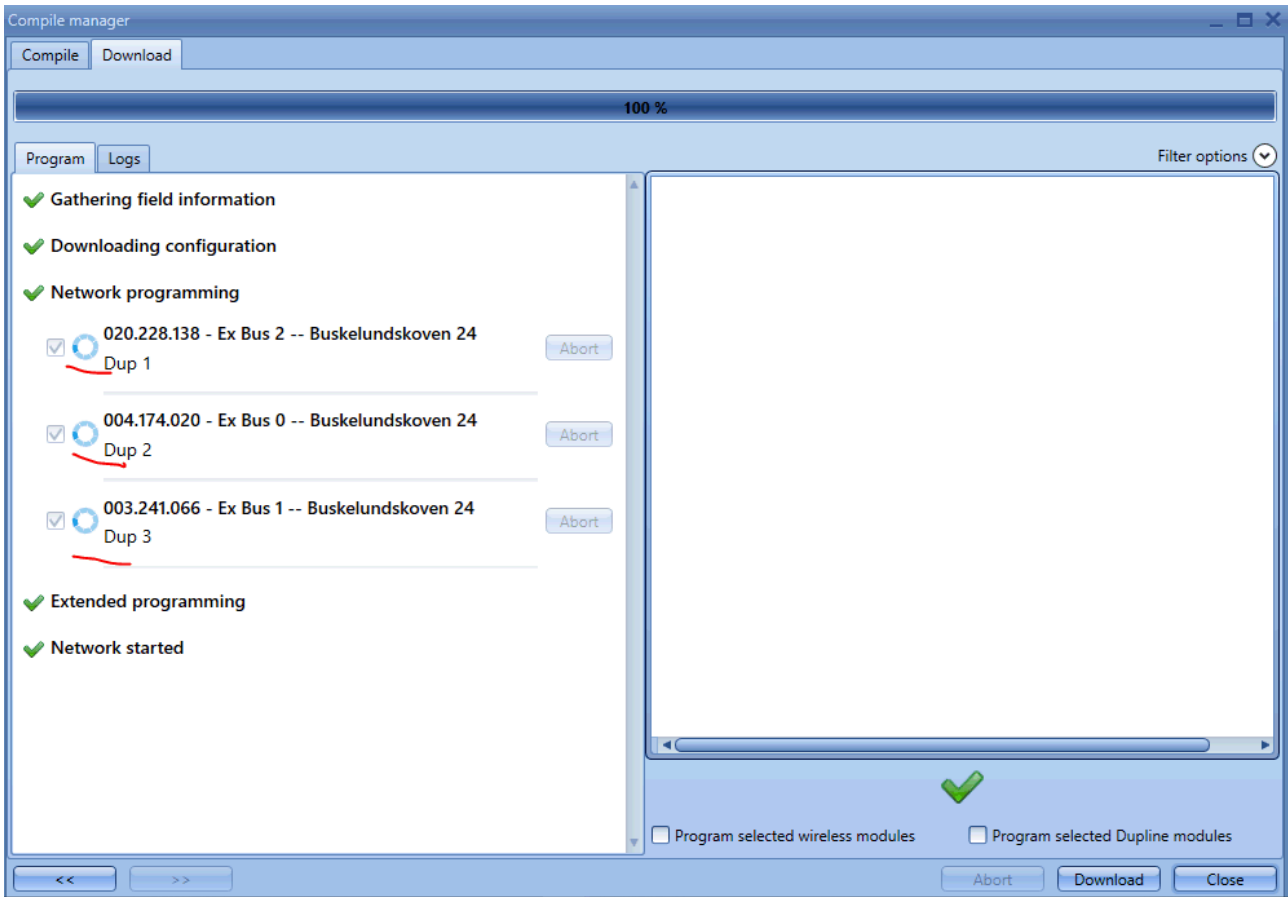
Configuration upload failing – Intruder alarm function and stress lights

Configuration upload failing after a modification of the stress light functionality in the intruder alarm function and the system does not work as expected (no error is shown when the software compiles the configuration). This problem occurs every time a light function is added as “stress light” signal in two or more intruder alarm functions.

It is mandatory to use each light function in one single *stress light* functionality

Note: It is not possible to add the same function in two or more different stress light fields.
