UWP 3.0 Tool Download

Tips & Tricks

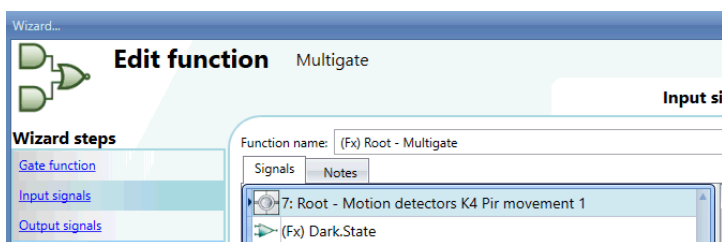
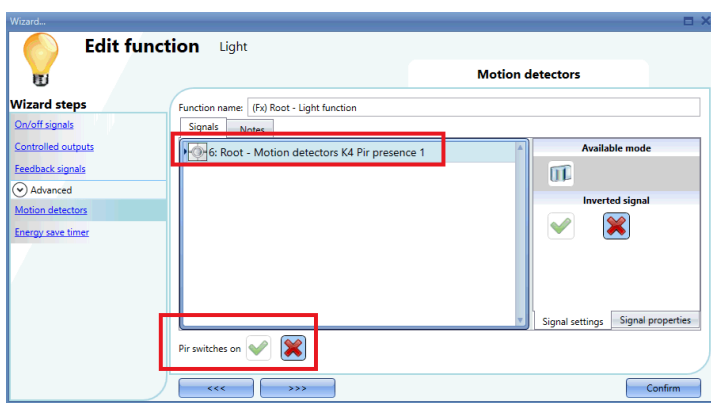
Energy save timer is not reloaded when the light level is above the threshold

At this point the lux value goes above the threshold and the energy save timer is not reloaded anymore, therefore the light goes off even if there is presence in the room.

Create an external analogue comparator that is used to define the "dark" condition. Use the comparator function as input of a multigate "AND" function combined with the *movement signal* of the PIR sensor.

Use the multigate as input signal (*On/Off Signals* tab) of the Light function.

In the light function, add the presence signal of the PIR.

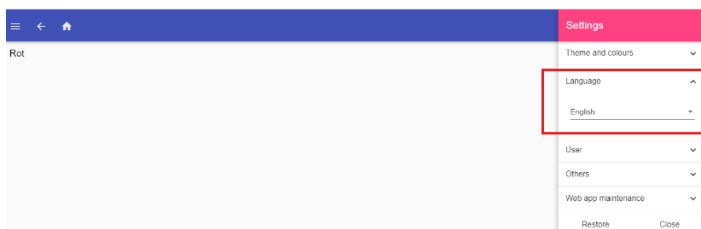
Reports created from web App shows wrong month

In the web app *Reports* window, you have created a template for a report in October 2018 but when you save and create the report, November 2018 data logs are shown.

You may face this issue if you run a Web browser with Norwegian or Chinese language.

The problem is due to the wrong default language that is automatically set by the Web App.

To fix this issue, navigate the web App settings, select the English language, then select again the correct language and save to apply the settings.

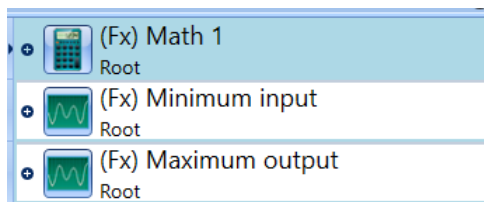
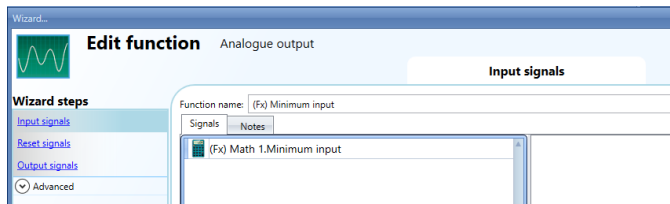
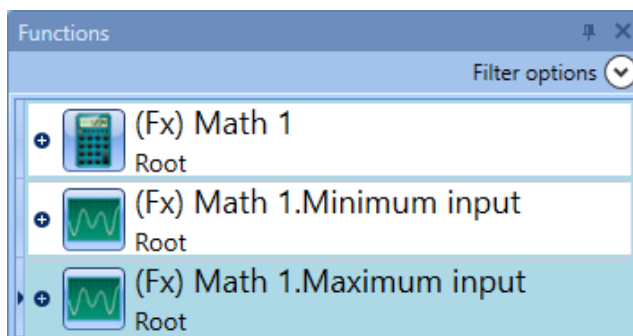
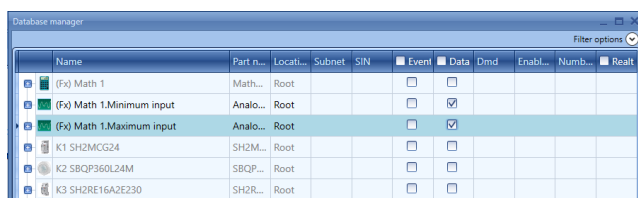
Not possible to log additional function status in the Database

In the Database window, the additional function status of a function is not available and it is not possible to log them into the Database of the system.

- a. Add to the project one Analog Output function for each additional status not available in the Database.

- b. Add to the analogue output function the additional status of the math function.

- c. Change the name of the Analog Output functions in order to have a clear description of the additional status (es. function_name + "additional_status").

- d. In the DB Manager add to the Database the Analog Output function.

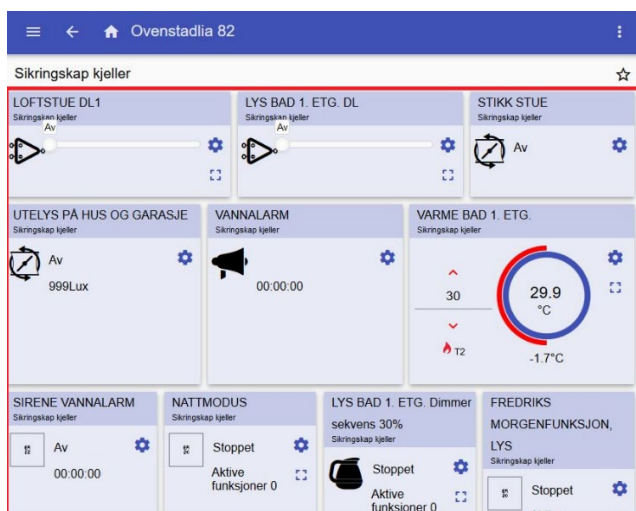
Wrong icons shown in the web App

After a firmware upgrade of the system the icons in the web App are not correct (the icons are messed up or missing).

The error is due to the cache of the web browser, the issue will be resolved cleaning the cache and logging-in again in the web App.

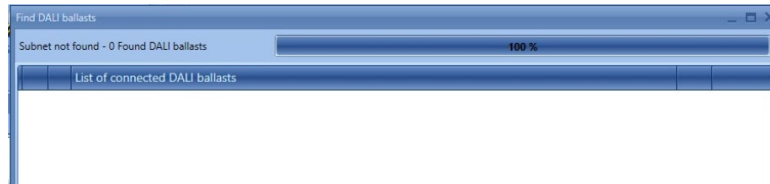
Not possible to scan the DALI network “subnet not found” error message appears

After adding the DALI module to the project, from the DALI module discovery window, the user tries to find the ballast connected, but when the search button is pressed, the discovery ends immediately with an error “Subnet not found”

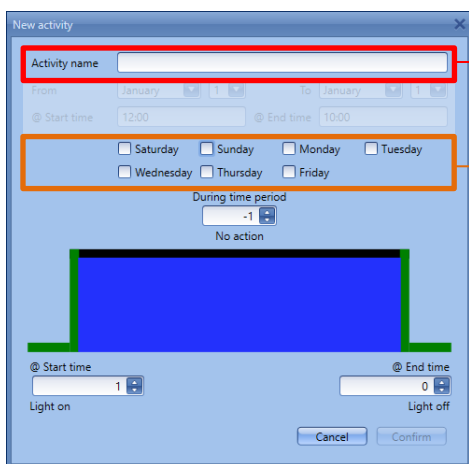
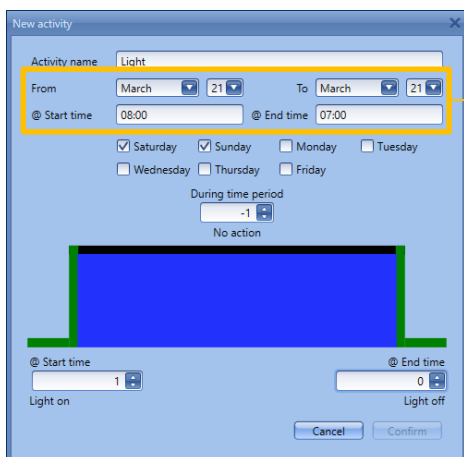
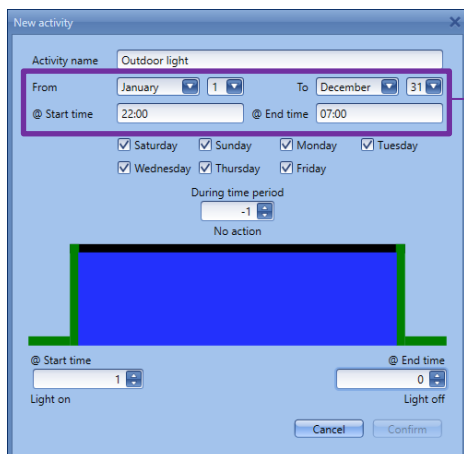
Calendar activities cannot be added

When a calendar activity is going to be added either in the *Local calendar* of the functions where it is available in the *Advanced* options, or in the *Global calendar* function, after filling the required fields the *Confirm* button cannot be pressed (this is shown in grey colour).

This happens if at least one of the following conditions is verified:

The *Activity name* field has to be entered

At least one week day has to be selected

a) With the same selected interval date (*From... To...*), it is necessary to set *@Start time* chronologically prior to *@End time*

b) Even with a different selected interval date (*From... To...*), it is still necessary to set *@Start time* chronologically prior to *@End time*

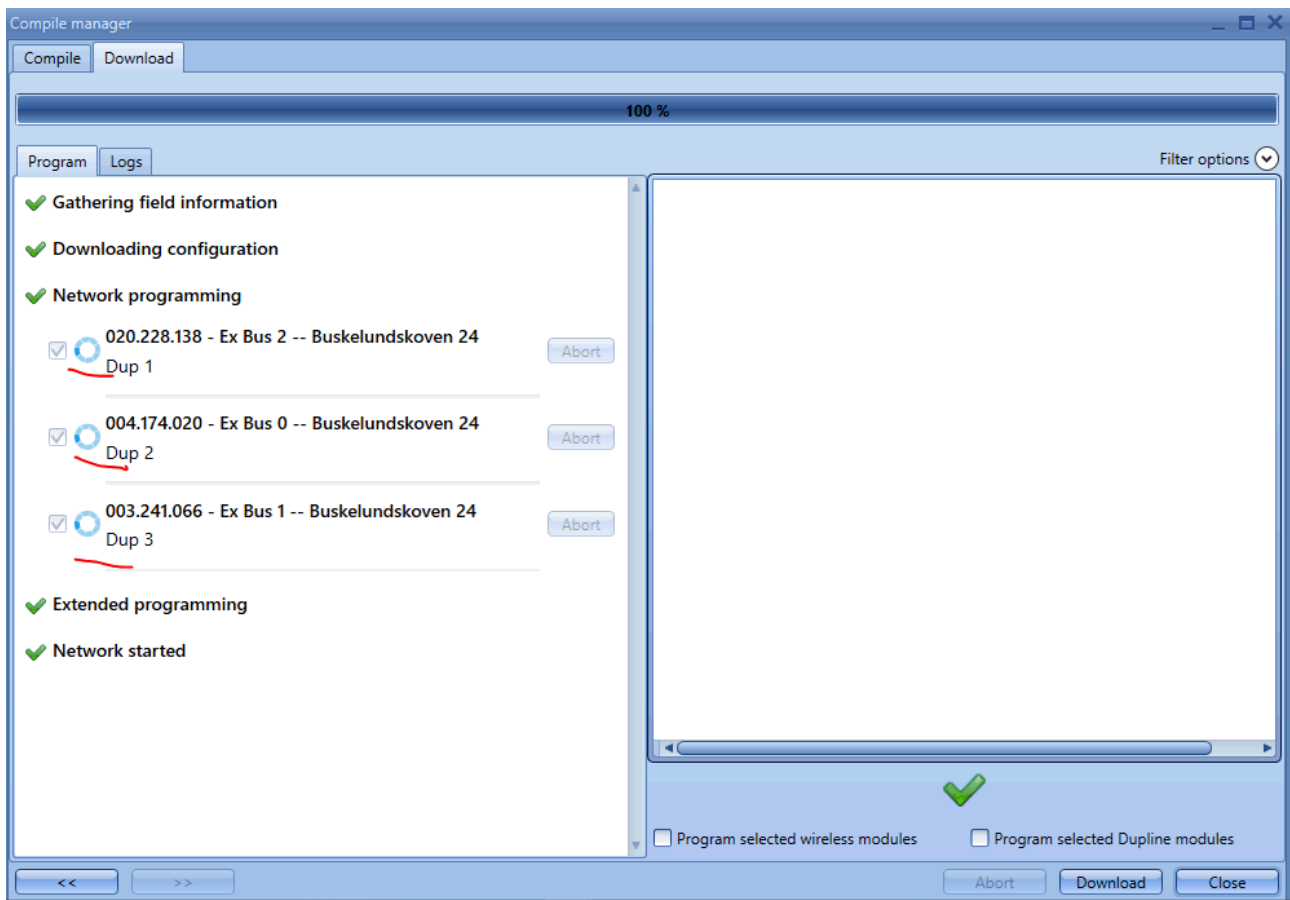
Configuration upload failing – Intruder alarm function and stress lights

Configuration upload failing after a modification of the stress light functionality in the intruder alarm function and the system does not work as expected (no error is shown when the software compiles the configuration). This problem occurs every time a light function is added as “stress light” signal in two or more intruder alarm functions.

It is mandatory to use each light function in one single *stress light* functionality

Note: It is not possible to add the same function in two or more different stress light fields.

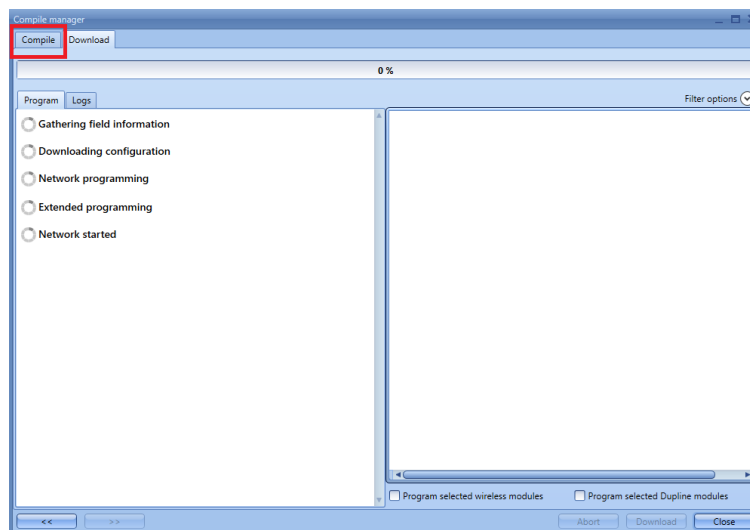
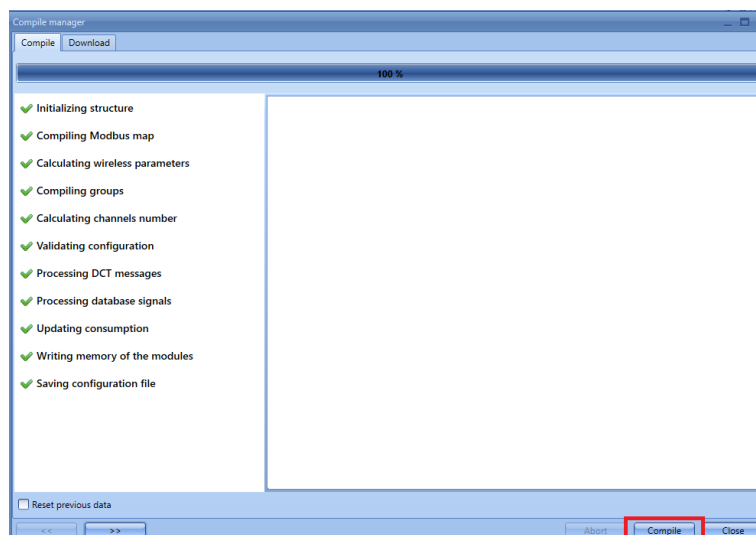
Download button is not available

The *Download* button is not selectable after clicking on the *Send to controller* button from the *Configuration* menu.

This problem occurs every time a pre-compiled configuration is loaded in the UWP 3.0 Tool and the user clicks on the *Send to controller* button without compiling the configuration file.

1. Do not close the *Compile manager* window and go back to the previous *Compile* window

2. Click on the *Compile* button at the bottom

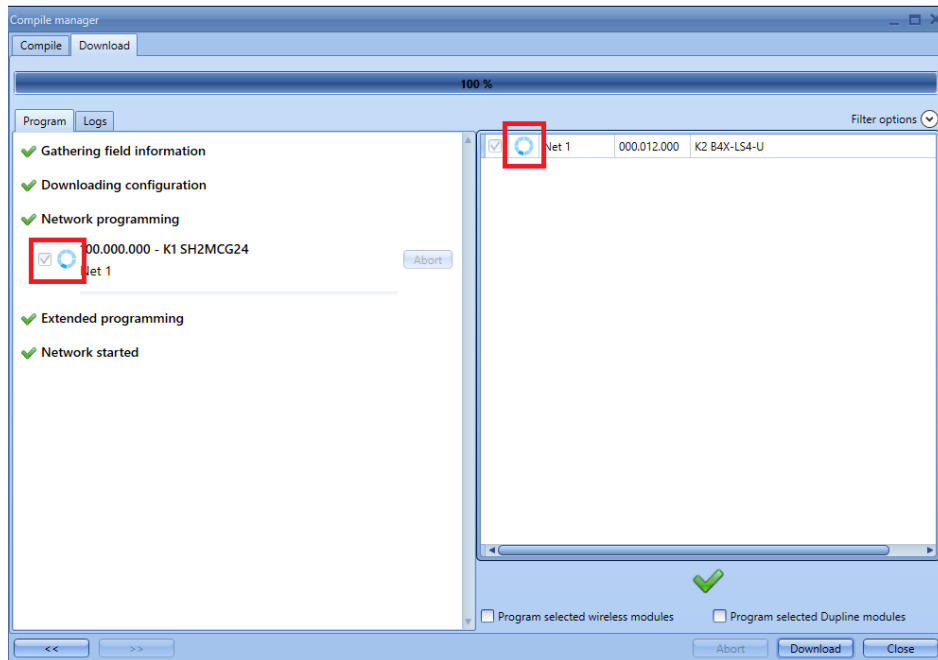
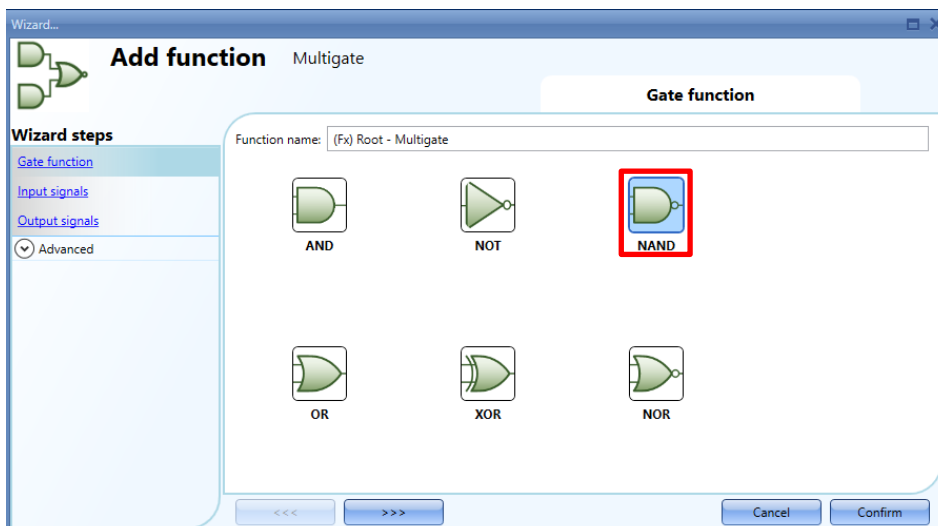
Download configuration shows 100% but the modules icons are not updated

The *Download* of the configuration leads to an issue in the *Download manager* window: the icons next to the modules keep spinning even if the progress bar shows 100%.

This problem occurs every time a project contains a *Multigate* function that is configured as NAND operator without input signals (the *Input signals* window is empty).

Delete all the *Multigate* functions without input signals from the project.

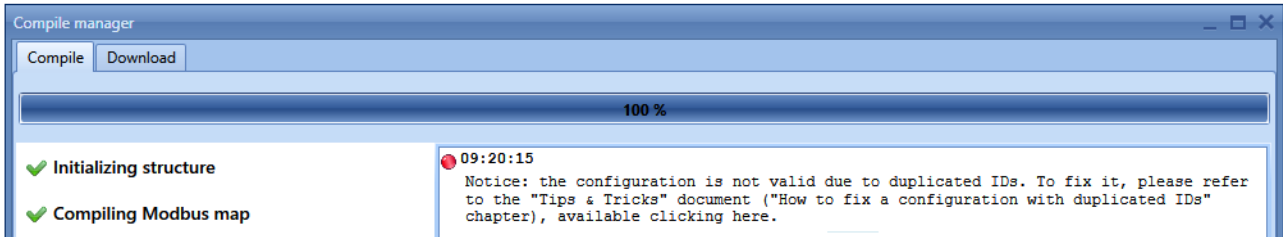
How to fix a configuration with duplicated IDs

If while compiling a configuration you get warned about duplicated IDs (see picture above), you can fix the configuration as follows:

1. Unselect all the signals enabled in the database.
2. Compile the configuration and save it on your PC.
3. Close and reopen the UWP 3.0 Tool.
4. Open the configuration previously saved.
5. Add again the signals to the database.
6. Compile so to be sure that the problem has been solved.
