CARLO GAVAZZI

Sx Tool Download

Tips & Tricks

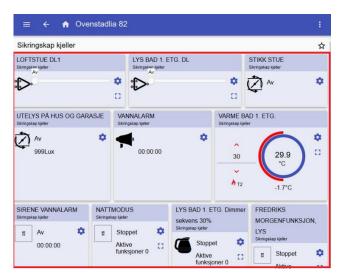
Wrong icons shown in the web App

After a firmware upgrade of the system the icons in the web App are not correct (the icons are messed up or missing).

The error is due to the cache of the web browser, the issue will be resolved cleaning the cache and logging-in again in the web App.

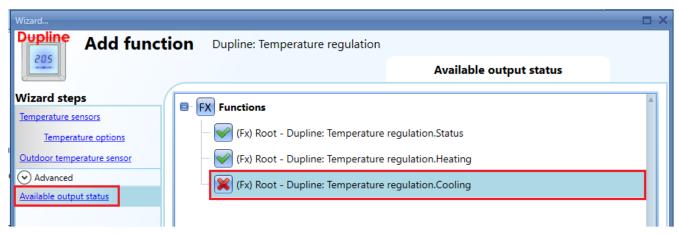
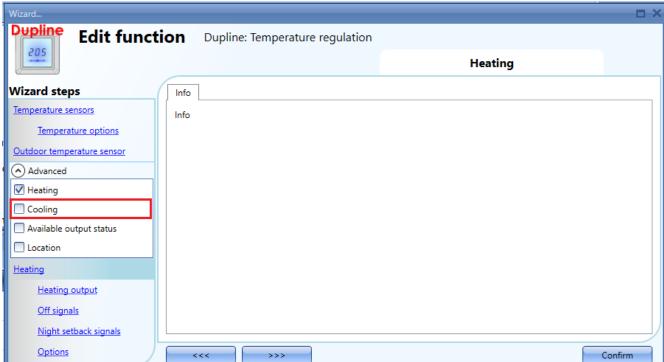
Dupline temperature regulation function deactivates the heating setpoint

When the advanced field Cooling is selected in the Dupline temperature regulation and there is no output signal used, the temperature function activates the cooling set point every time the configuration file is sent to the controller, consequently the heating function goes from heating T1 to TOFF and stops heating.

This problem happens also when the controller restarts because the system loads the configuration at startup and the cooling setpoint is activated.

In the advanced menu "available output status" the signal temperature regulation. Cooling should be deactivated.

The advanced menu "Cooling" should be unselected.

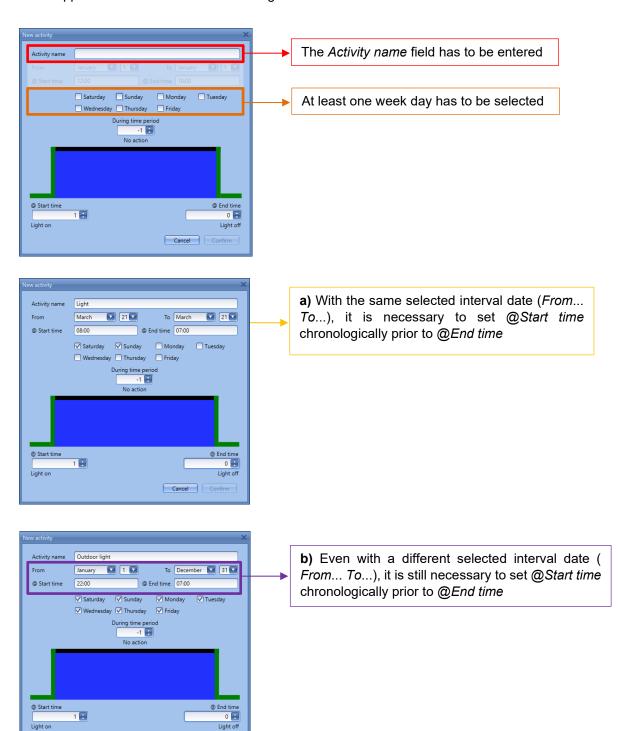
Calendar activities cannot be added

When a calendar activity is going to be added either in the *Local calendar* of the functions where it is available in the *Advanced* options, or in the *Global calendar* function, after filling the required fields the *Confirm* button cannot be pressed (this is shown in grey colour).

This happens if at least one of the following conditions is verified:

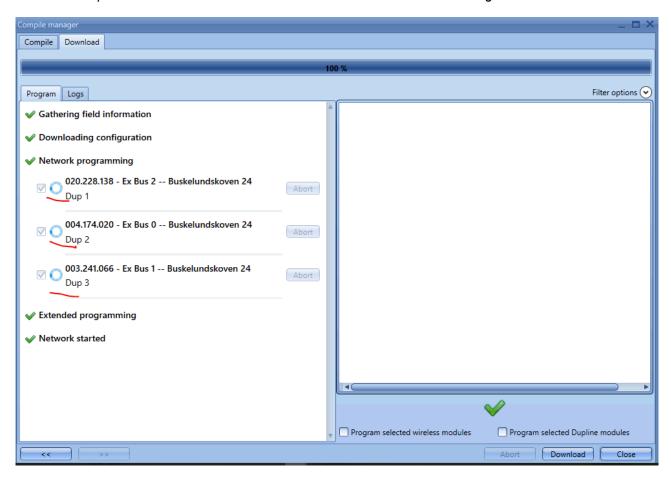
Configuration upload failing – Intruder alarm function and stress lights

Configuration upload failing after a modification of the stress light functionality in the intruder alarm function and the system does not work as expected (no error is shown when the software compiles the configuration). This problem occurs every time a light function is added as "stress light" signal in two or more intruder alarm functions.

It is mandatory to use each light function in one single *stress light* functionality

Note: It is not possible to add the same function in two or more different stress light fields.

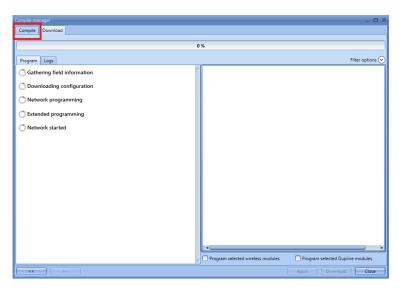
The *Download* button is not selectable after clicking on the *Send to controller* button from the *Configuration* menu.

This problem occurs every time a pre-compiled configuration is loaded in the *Sx Tool* and the user clicks on the *Send to controller* button without compiling the configuration file.

1. Do not close the Compile manager window and go back to the previous Compile window

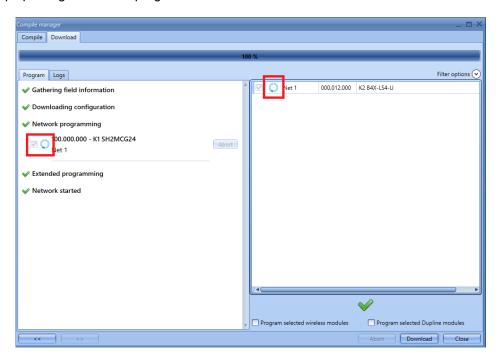
The *Download* of the configuration leads to an issue in the *Download manager* window: the icons next to the modules keep spinning even if the progress bar shows 100%.

Delete all the Multigate functions without input signals from the project.

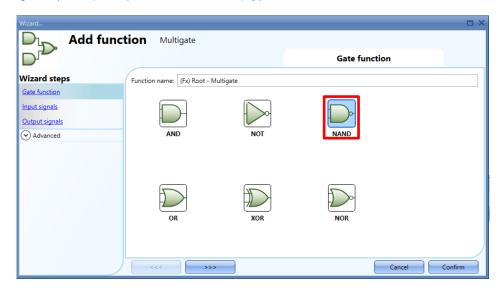
This problem occurs every time a project contains a *Multigate* function that is configured as NAND operator without input signals (the *Input signals* window is empty).
