UWP 3.0 Tool Download

Tips & Tricks

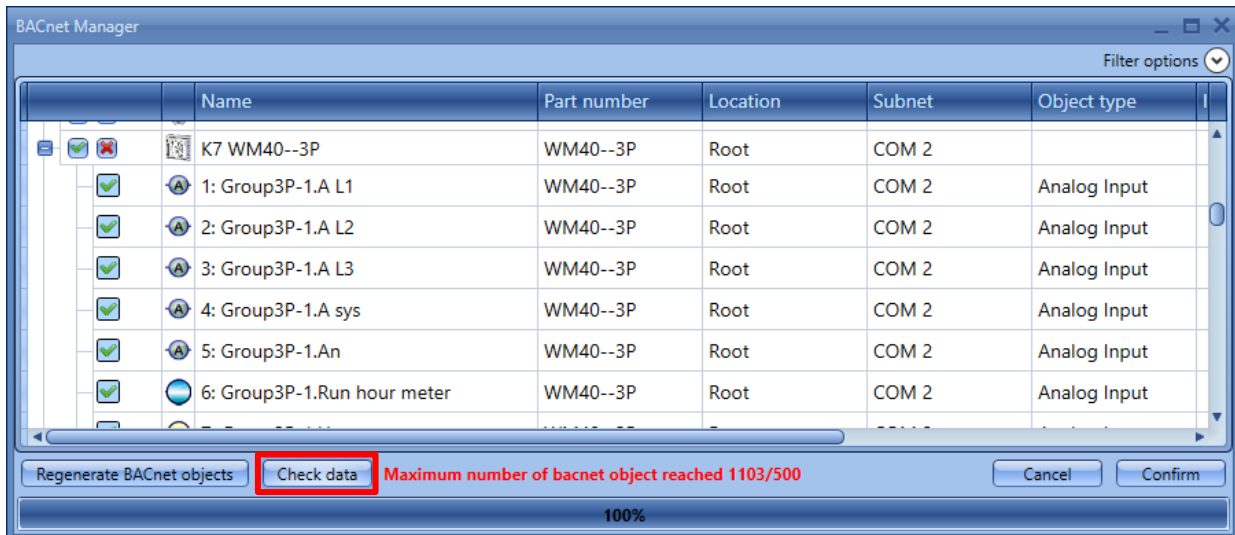
Important: Starting from the version 8.2.9.3, up to 500 BACnet Objects can be managed in a project.

As shown in the example above, a warning message will be displayed if the maximum number of BACnet Objects has been exceeded and their amount; otherwise the **Ok** message will be displayed when it is compliant.

Note: It is mandatory to delete the excess BACnet Objects and compile the configuration before sending the project to the UWP 3.0 controller.
